BALANCE TOPSIDE WORK PIPELINE REPLACEMENT PROJECT-VI	CLIENT DOCUMENT No. C294-GEN-POCT-001
	PROJECT SUMMARY REPORT	
		REVISION No. 0

SITE COMPLETION CERTIFICATE

Customer : ONGC
 Contract No. : MR/ES/MMBTWPRPVI/NOM/22/P851S22007
 Project : BALANCE TOPSIDE WORKS FOR PIPELINE REPLACEMENT PROJECT VI (BTWPRPVI)
 Platform : PPA PLATFORM
 Contractor : SUPREME OFFSHORE CONSTRUCTIONS & TECHNICAL SERVICES LTD
 Barge : SHIVANSH SHAMBHAVI / GOODMAN

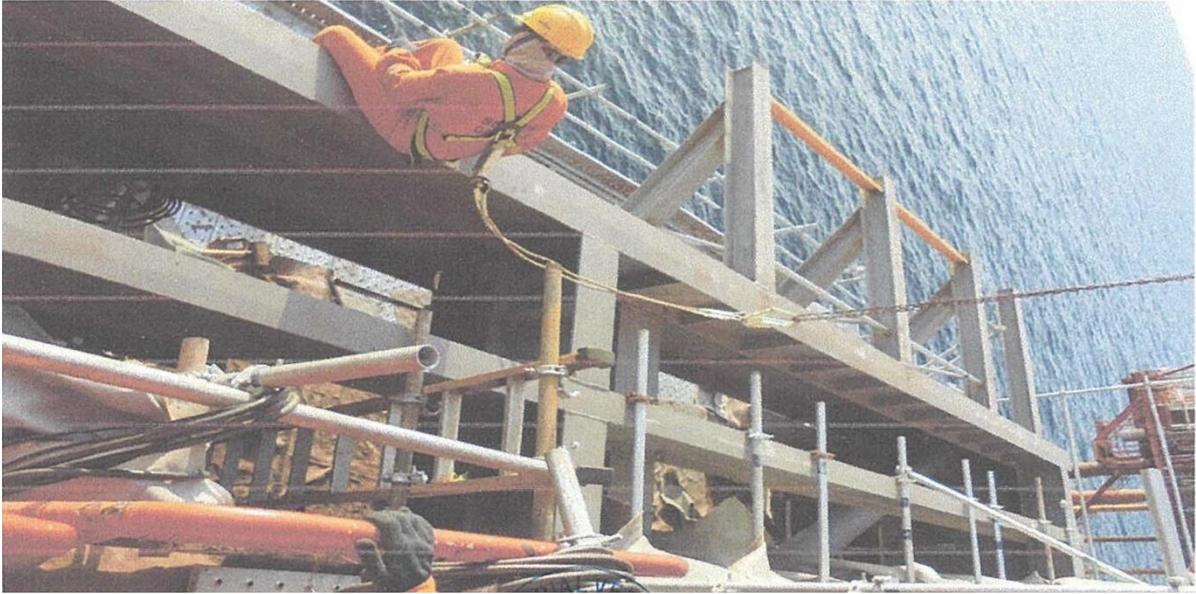
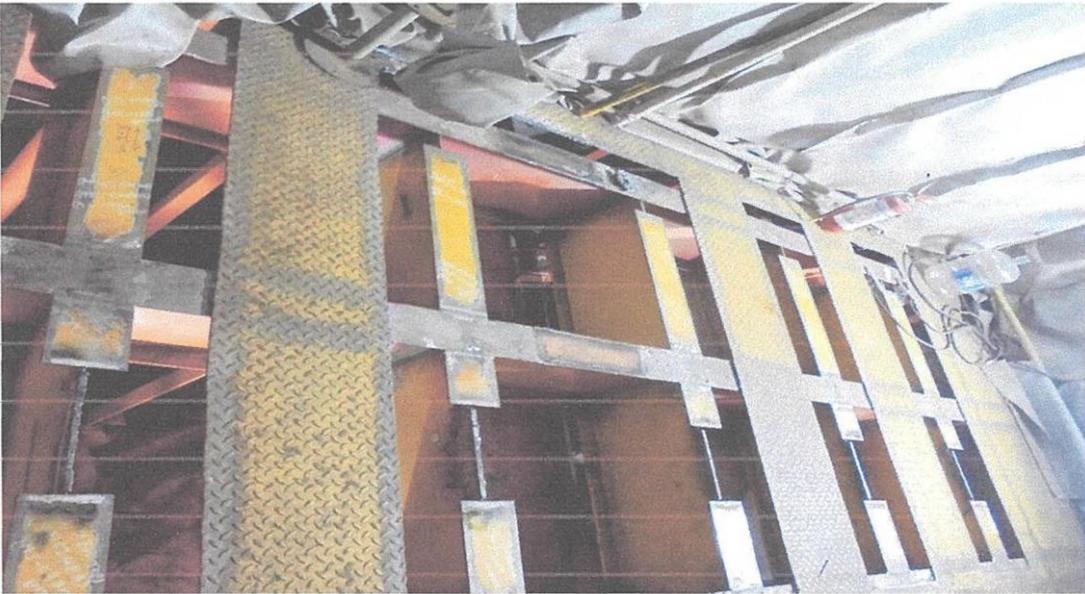
2.1.1.1 Structural strengthening & Deck Extension.

1. Installation of deck extension for battery bank container
2. Deck Strengthening for HT Container
3. Deck Strengthening for MOL Pumps
4. Deck Strengthening for Booster Pumps

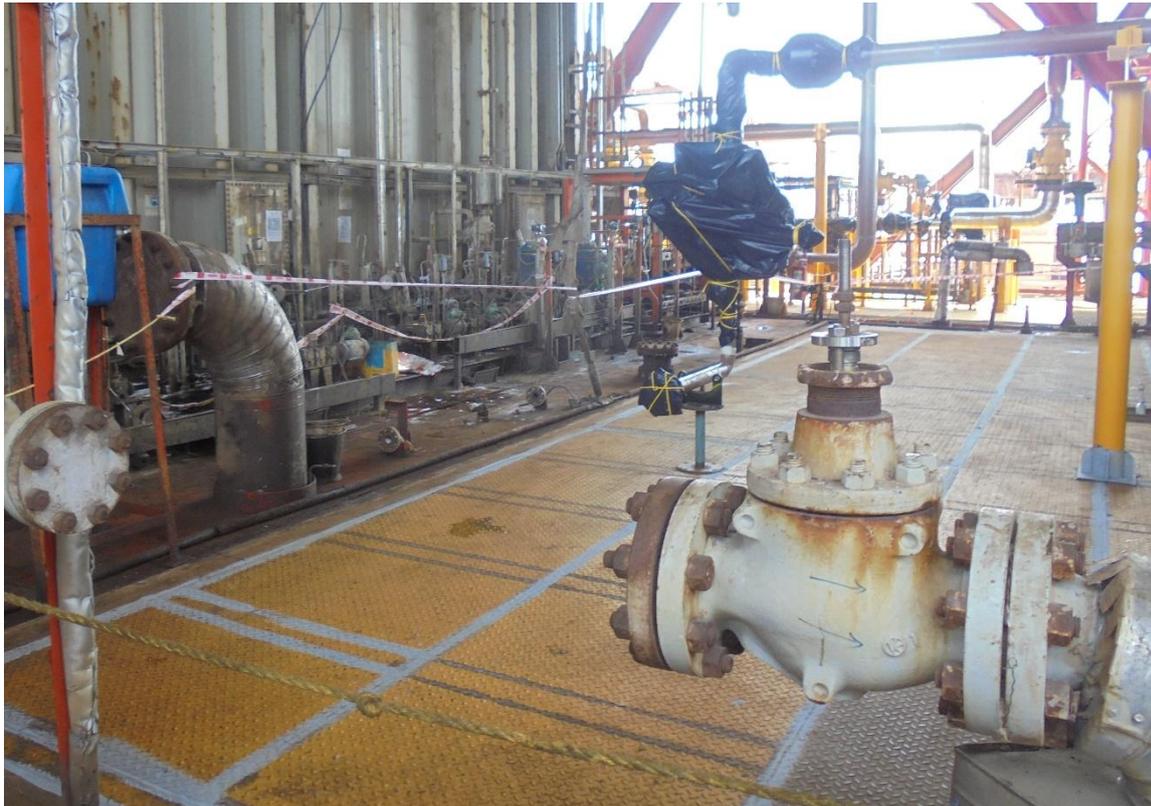
2.1.1.2 Demolition

1. Demolition of Booster Pump with associated piping
2. Demolition of existing wet oil tank with associated piping.

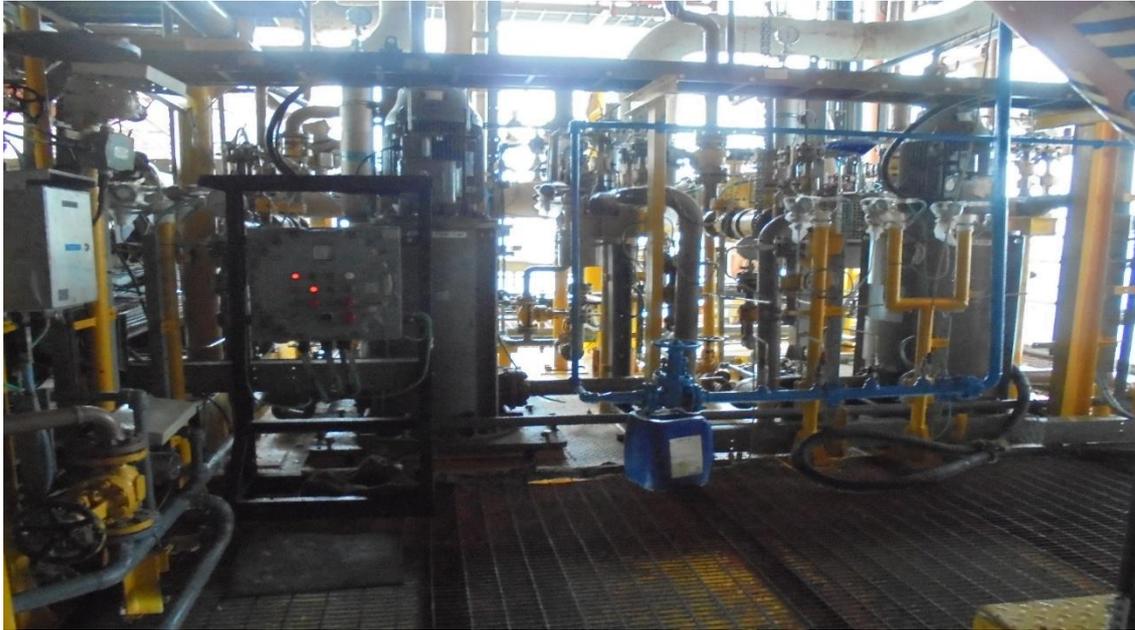
2.1.1.3 Booster Pump (P-3170, P-3180 & P-3190)

1. Installation of 3 no`s of booster pumps completed

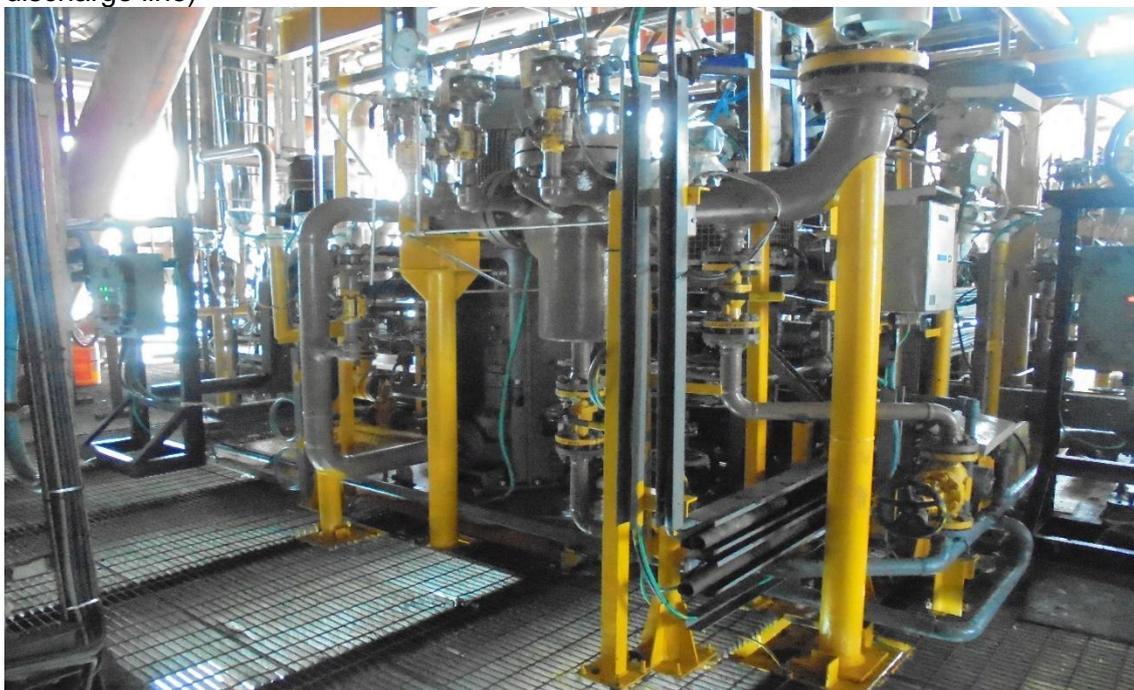
2. Hook up of balance piping work & instruments associated with Booster pumps (suction line, discharge line)

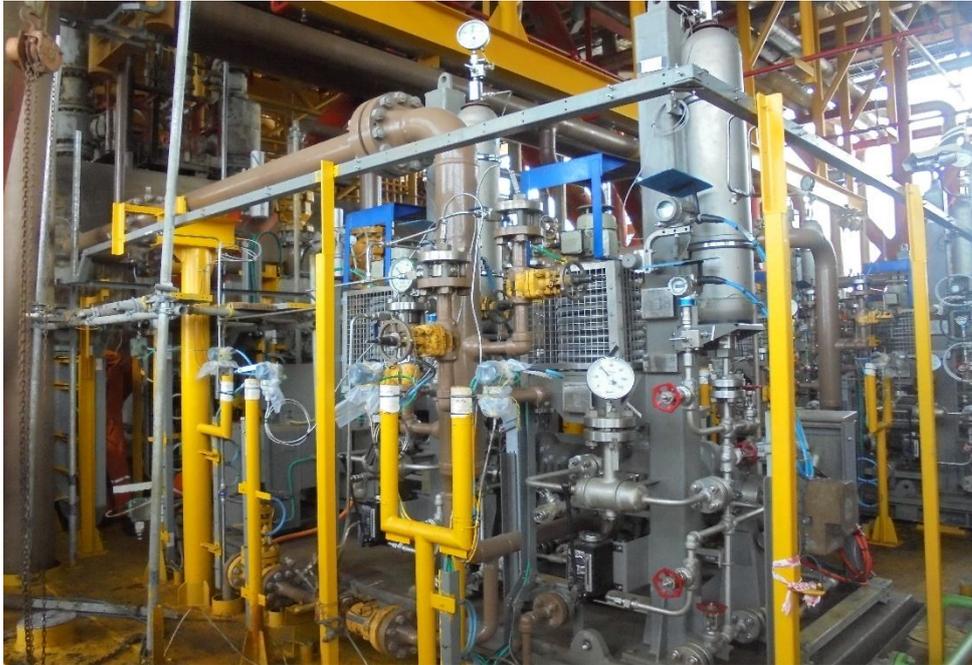
2.1.1.4 MOL Pump (P-3270, P-3280 & P-3290)

1. Installation of 3 no` s of MOL pumps

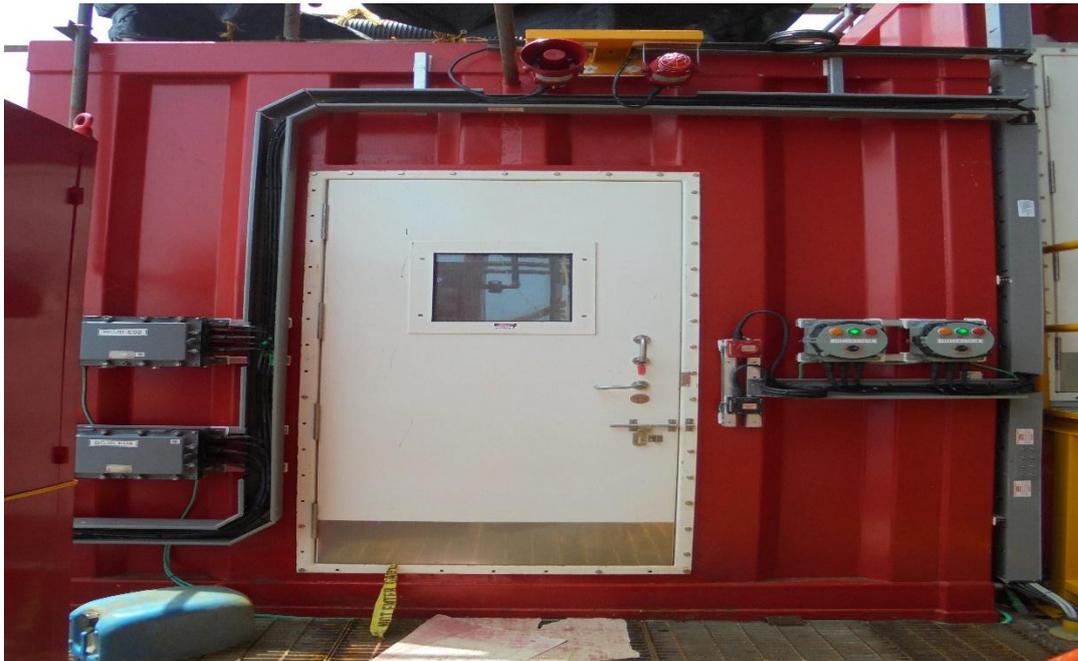
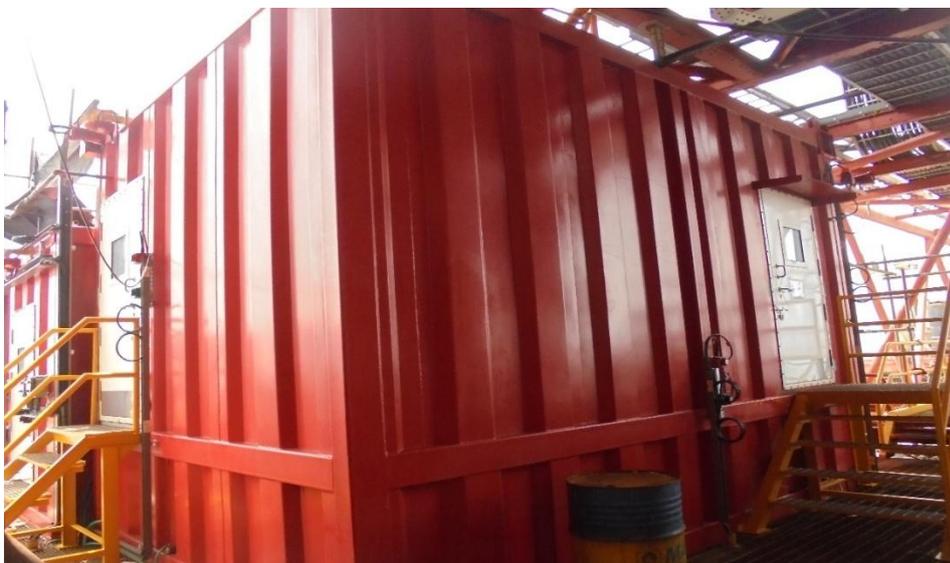
8.1.2.3. Pressurized HT Container:

1. Installation of HT Container & Battery bank container .
2. Installation of HT panel, cable laying, cable tray installation, Instruments & Commissioning activities of electrical and instrument items
